Glide-snow avalanche management

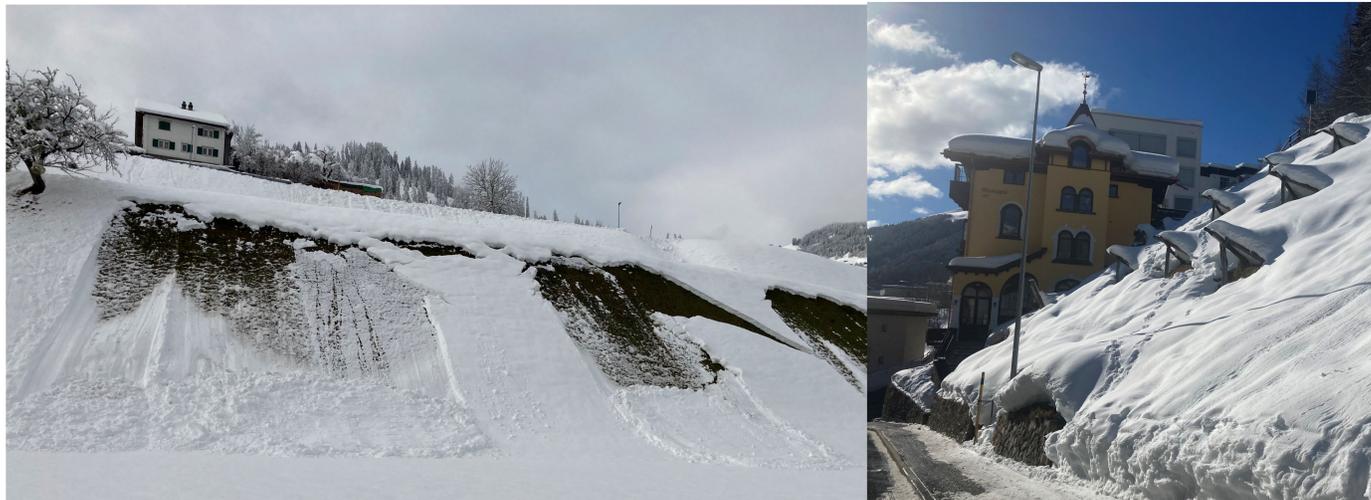
Figures 1: (Left) Gliding snow avalanche in Jenatz (GR). Following snow fall events, the steep banks regularly fail as glide-snow avalanches along the low friction grass layer. (Right) Traditional stabilisation measures using wooden tripods are placed in glide-snow affected slopes to retain the snow.

Gliding snow avalanches (Fig. 1 & 2) are a result of continual snow pack creep, leading to full failure and sliding. Gliding and failure occurs along the snow-ground interface on slopes between 25 – 35° (Fig. 3). The ensuing gliding-snow avalanches cause damages to infrastructure (Fig. 4) and life. The principal problem they pose is their unpredictability. Gliding snow packs have a considerable impact on the management of ski areas, transport corridors and spatial planning. With a warming climate there appear to be increasing reports of gliding snow hazards in alpine regions.

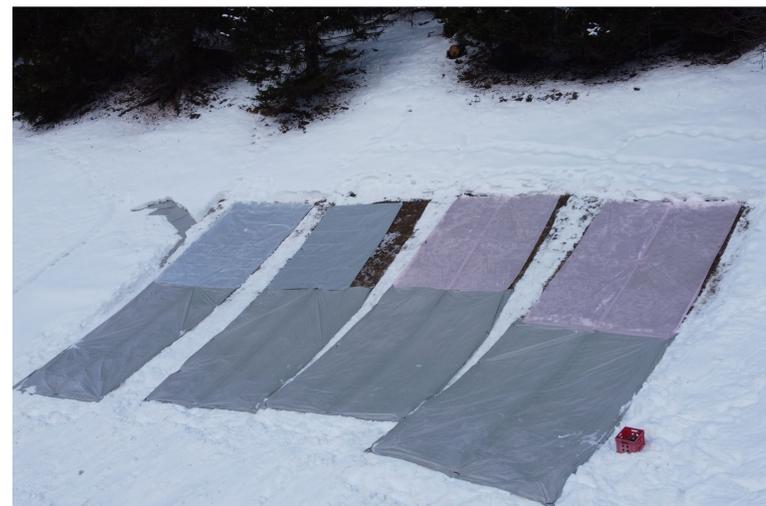
Figure 3: Geotextiles installed on slopes between 25 and 35°.

In this proof of concept research, a series of hydrophobic low friction geotextiles were installed on slopes between 25 and 35° at 1700 m a.s.l. and observed during the winter (Fig. 3). The slopes were sun affected for half of the winter season. Initial observations show that snow accumulations quickly release and clear from the geotextiles.

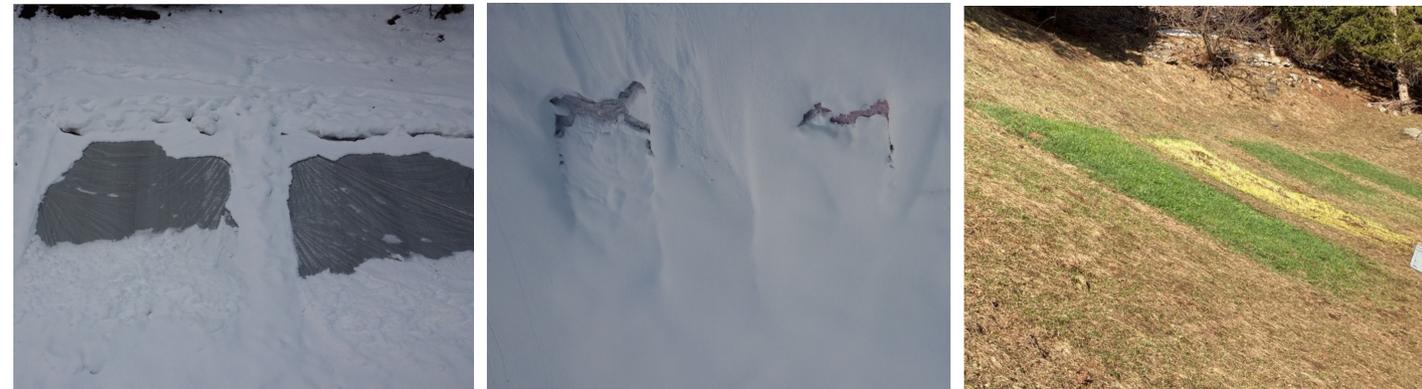
Figures 4: (Left) Glide-snow deposits accumulate at the base of the slope being supported from snow pack without geotextile. (Middle) Large snow fall events, sliding of the snowpack also occurred despite the support from the stauhwall. (Right) Removal of the geotextiles in spring revealed a positive greening effect due to the geotextiles; opaque geotextiles lead to some damage to the natural grass regions.

Snow deposits from the slides do however accumulate at the base of the slope where support is given from the stauhwall and flanking snow pack that do not have geotextile material. Continuing snowfall then fills the region of the geotextiles based on the support from the surrounding stable snowpack (Fig. 4).

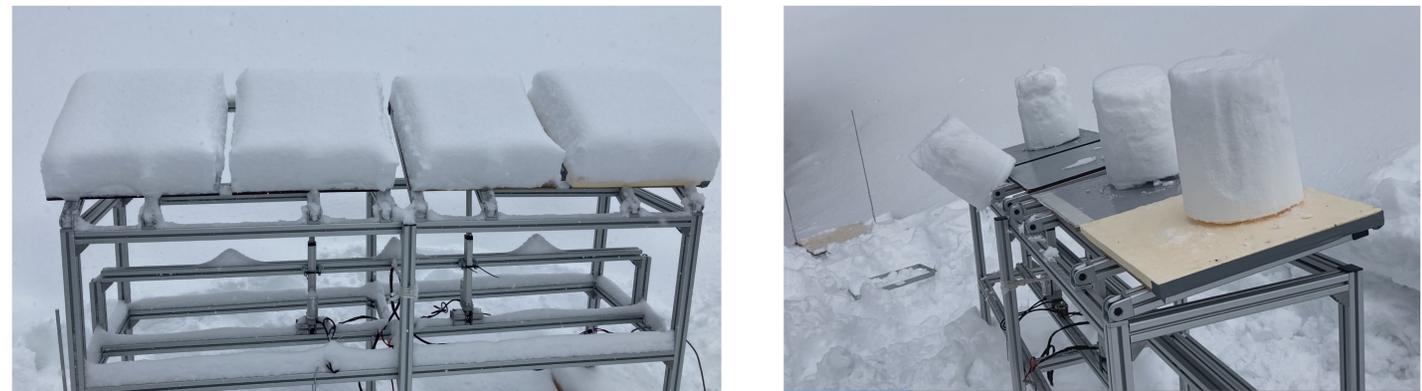
Figures 5: (Left) Tilt-plate with natural snow accumulations. (Right) The geotextiles tested in the experiment series were placed on the tilt-plate and tipped to determine the slope angle at which different snow samples slipped off the tilt-plate.

The tilt-plate experiments identify the friction angle of geotextiles under different snow conditions. Conditions >0°C promote water accumulation and early sliding of the snow and shallow friction angles. Melt followed by freezing phases can cause the snowpack to adhere to the geotextiles. Porous geotextiles proved ineffective at snow removal.

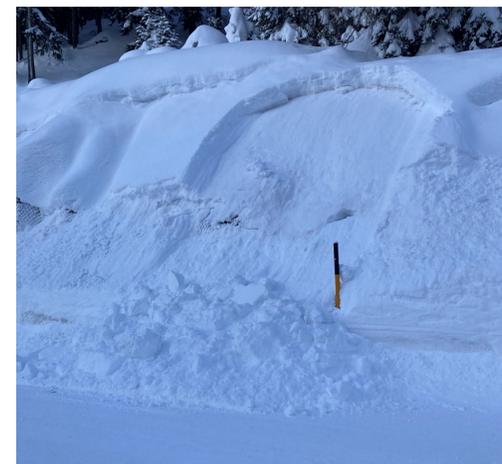
Figures 6: Natural snow slide onto open road in winter.
